EMORY JONES HOUSE

INVENTORY FORM FOR STATE HISTORIC SITES SURVEY

CT-14

2. NAME Emery Jones Gambrel Roofed House DATE OR PERIOD mid 18th century STYLE Maryland Colonial ARCHITECT _____ BUILDER _____	
		LIBRARY OF CONGRESS USE _____

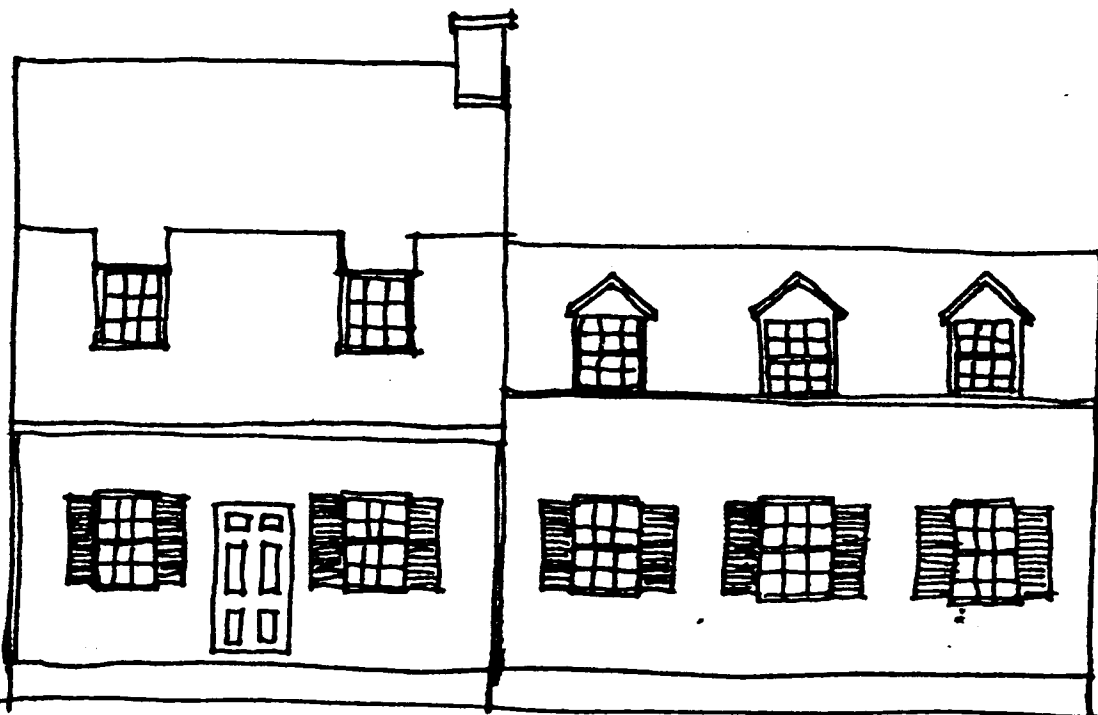
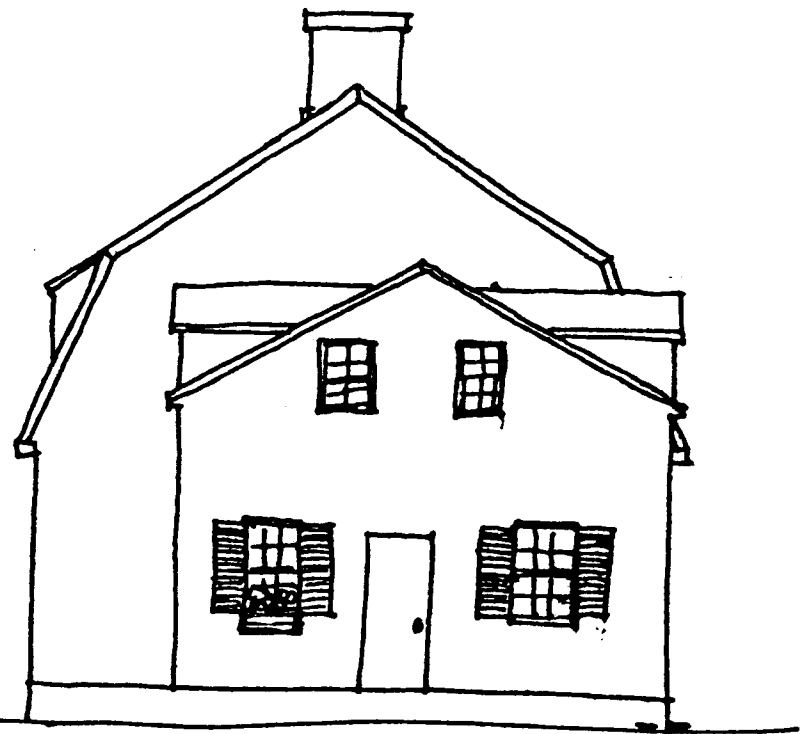
CT-14 Dowell H^{se}
(Emory Jones Hs.)
renovated with addition
of Sunderland School House
Merry Stinson April 7, 1988
sketch at 1/8" scale

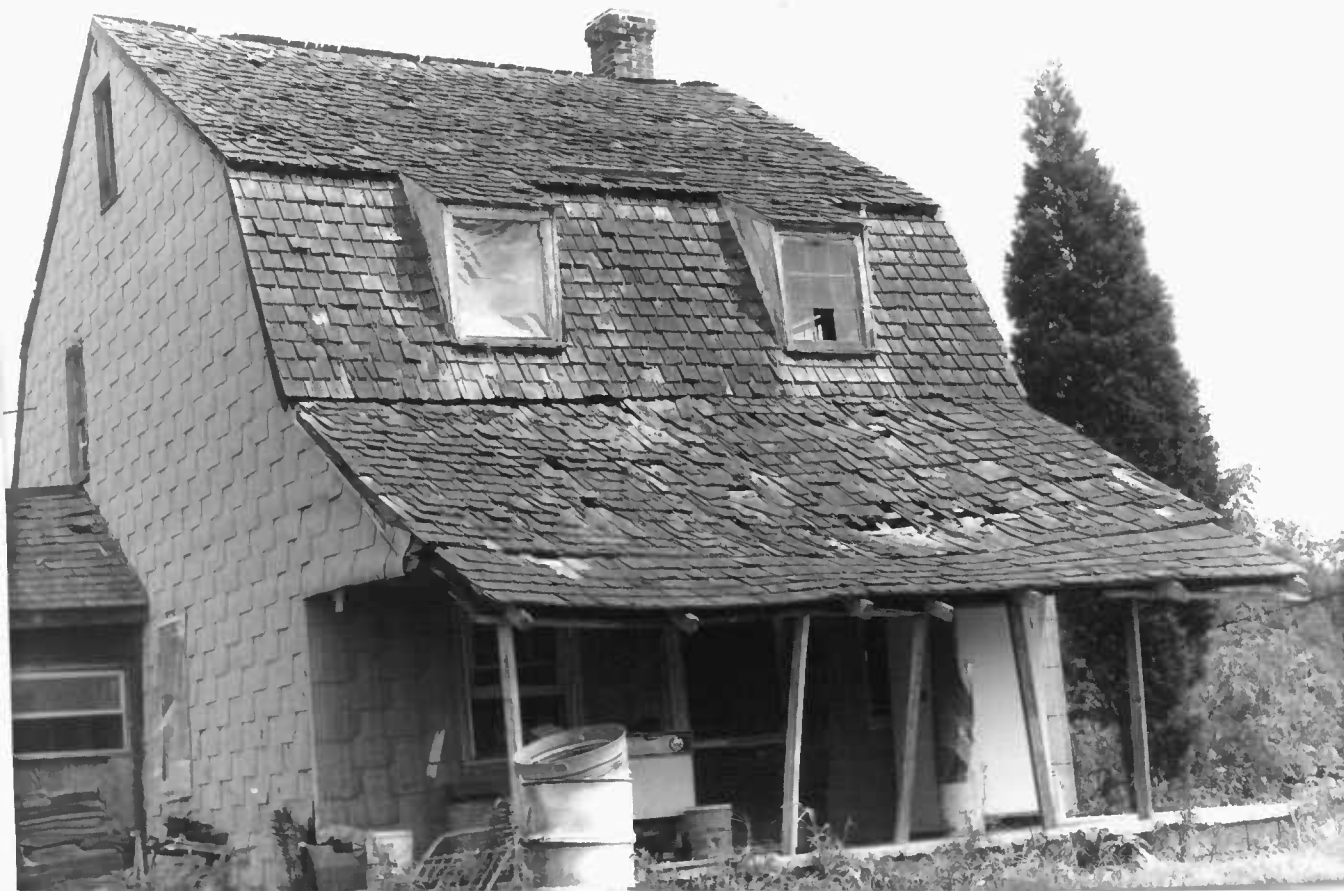
CT-14

SW.

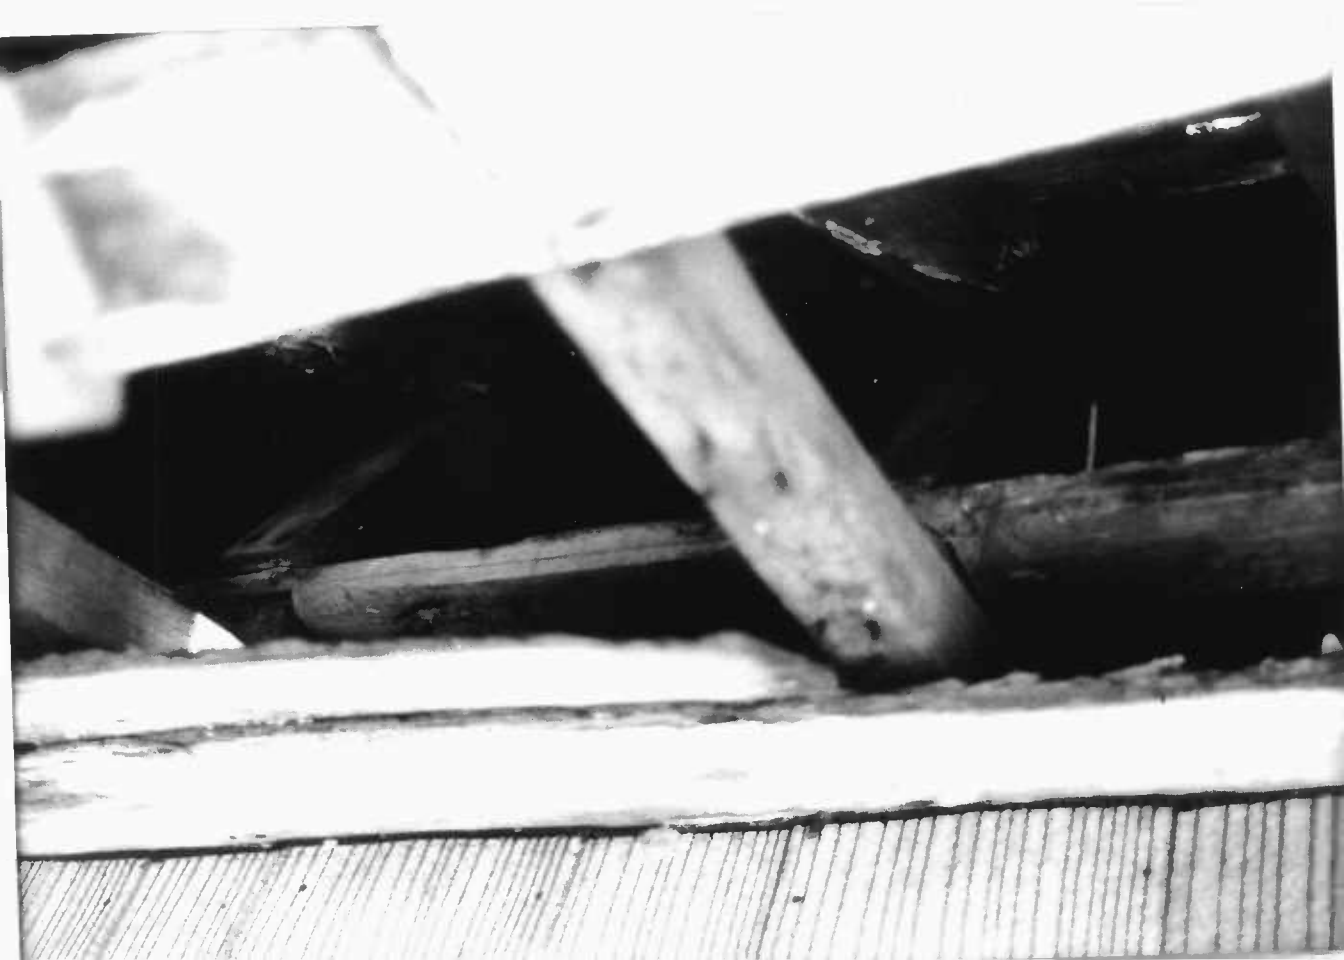
CT-14

Where the porch joins the caves on the south facade; it is collapsing thus exposing hand-hewn timbers joined with rose-head nails.

Emery Jones Hs.
eaves construction,
seen under ~~E~~ porch
S.
